Networking

Newsletter

Analysis from the Sleuth (Michele Winn)

The case study this month is a 1995 Buick Roadmaster with a 5.7L engine, automatic transmission and approximately 52,000 miles. (Fig. 1) The customer complained that the vehicle would intermittently misfire at idle and sometimes on acceleration. The vehicle had been to several other shops in the area who could not duplicate the problem.

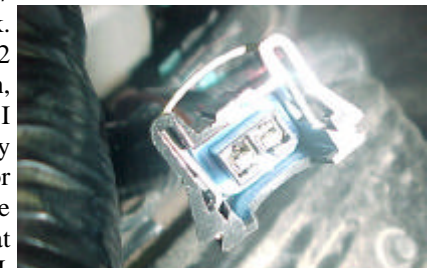
Fig. 2

A lengthy test drive only confirmed what others had said. The vehicle was running great! I pulled into the stall and hooked up the Allen SEA for a full system test. As expected, no problems were found during the test. While I was un-hooking the vehicle from the scope, I felt the engine start to misfire. Jim had been teaching a GM class while I was working. He decided to take a break just as the vehicle began to run badly. One of the guys walked over to the car, looked around under the hood and said, "I think I see the problem. Injector #7 is unplugged!" He plugged the harness back on to the injector and the car seemed to smooth out. Jim suggested checking for codes with the Tech-2. Only one code was found.....Code 18, Injector Circuit. This was not a big surprise to anyone. We assumed this code was set because injector #7 had been unplugged. The code was cleared and everything seemed to be ok. A few minutes later, the car stumbled and started missing again. The Tech-2 was still in the front seat, so we ran an injector balance test. Sure enough, injector #7 was dead. The harness was plugged in solidly this time, but I removed it to take a closer look. I noticed the terminals were bent and probably not making connection with the injector. (Fig. 2) I consulted the injector "wizard" and he had a replacement connector. A couple pieces of solder, some shrink tubing and we were ready to go. I started the engine this time sure that the problem would be fixed. No such luck. The car was still missing. I checked for new codes and I had a Code 18 once again.

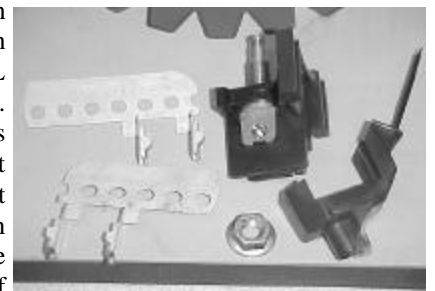
Fig. 3

The fix called for several parts (available only thru the local dealer). When I began taking everything apart, I could definitely see marks on the bus bars where they were discolored, probably from heat. (Fig. 3) The plastic cover that protects the stud was also melted. (Fig. 3) The job called for one hour labor and it can easily be done in that length of time.

Never would we have (*at least using conventional thought processes*) come up with a burnt buss bar (*which happened to be the main injector fuse feed as well*) to cause this problem.

I called the customer and advised him of the bulletin and of our findings on iATN. He quickly agreed to the repairs, even though I did not give any guarantee that this would definitely fix his problem.
