The Official Newsletter of LINDER TECHNICAL

FLATRATER PUZZLE PALACE ???

DECEMBER 1999

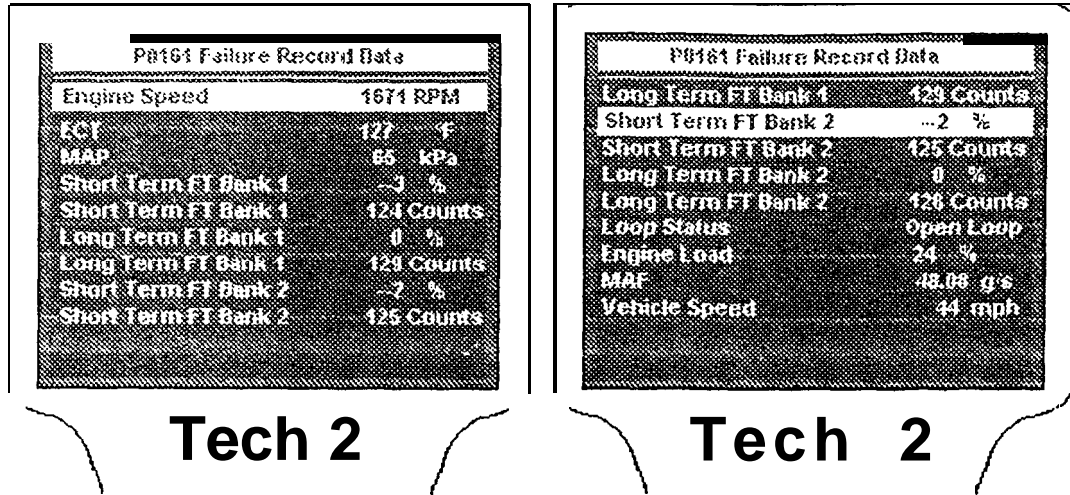
The Failure Record

As you can see, the data is exactly the same as the Freeze Frame. This means that the diagnostic has not failed since the failure that set the Freeze Frame and illuminated the MIL. This does not mean that the problem is gone however; the test may not have been run since the failure that set the MIL. Now lets press a soft key and see what that code is for...

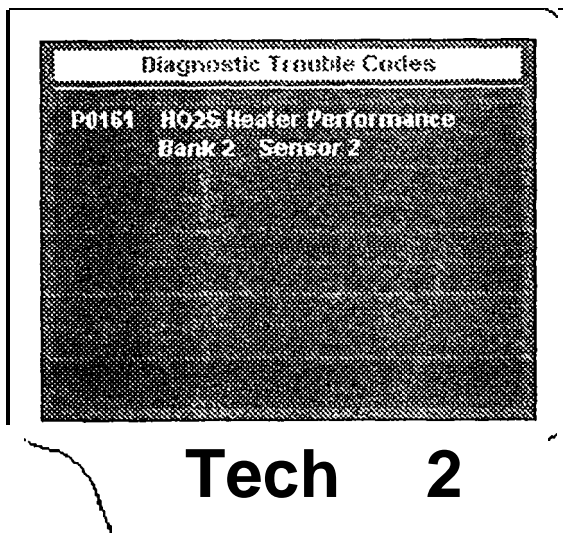
Interesting no? I let the engine cool down for 10 minutes and tested the O2 heaters by leaving the key on with the engine off. All 4 O2 sensors started out at 450mv and were below 175mv within 3 minutes. Oxygen sensor heater circuits are tested upon cold startups while watching for sensor activity. Chevrolet trucks do not currently monitor the actual current. They are tested while monitoring "time to activity" or TTA.

This Oxygen sensor looks ok. Could it be inoperative at times? Sure, but I don't think that is the case. I think it's tied into the rough running for some reason. With the Tech 2 and a fuel pressure gauge, I ran a quick injector flow test. All the injectors appeared to flow about the same. Although this is obviously NOT a scientific test, experience so far has shown that it is more than adequate. Now before we stuff a gas analyzer up the

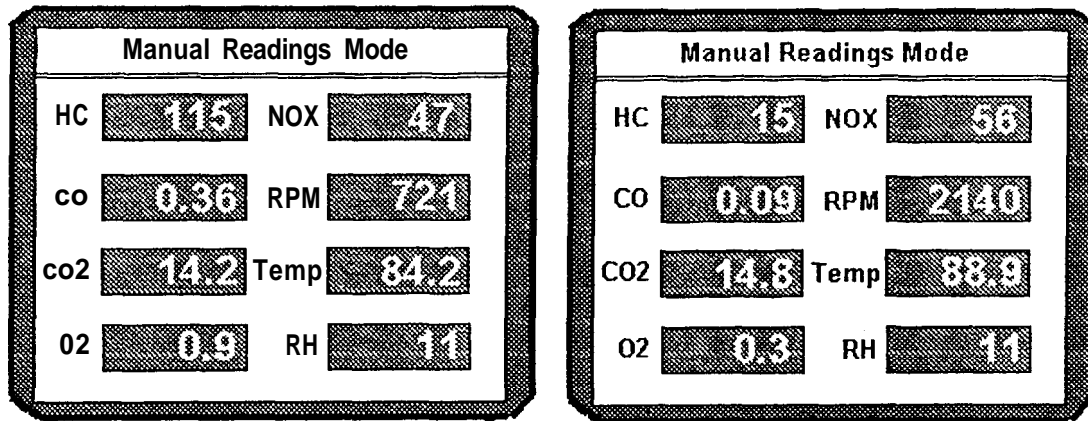
There are NO vacuum leaks... What do you think the fix for the rough idle was, and would you believe that it took care of the P0161? Note, I am not going to defend the logic of the onboard diagnostics for this one....

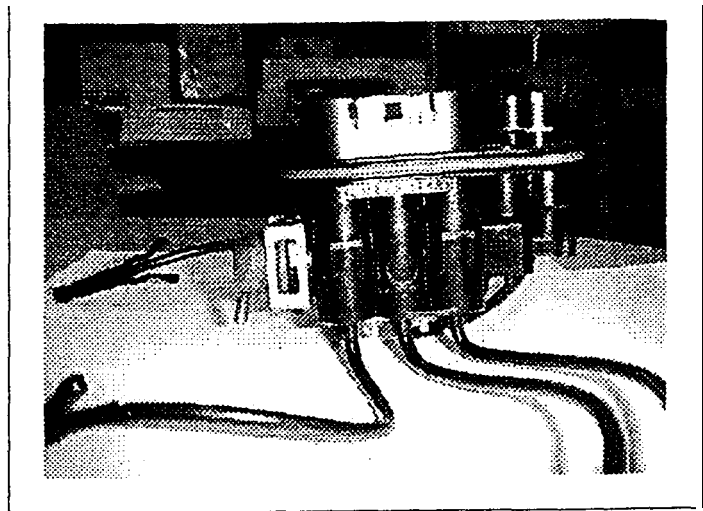
I had a call on the hotline a few weeks ago from a technician that had installed one of these CSFI units in a truck and wanted to know if the tubes had to go back in the same spot. The answer is a definite YES! On the old CPI unit, it wouldn't have made any difference because all of the cylinders were getting fuel at the same time, but on a sequential system, the tubes must be in the proper order.

For those of you wondering, on the side of the "pod" each one is labeled. Fuel pressure on these new systems is slightly higher, 60 – 66 psi with pump running and engine off. Sticking poppets also seem to be a problem with these systems. GM has an on the car cleaner designed to free sticking poppets. I recently heard from a technician at a GM dealer that he had to run the system up to 80psi before he had any luck with the cleaner. We have just recently started seeing these systems in our fuel injection room. As more and more go through the system, we will have more detailed information on testing and repairing these CSFI systems.
