Networking

Newsletter

Analysis from the Sleuth (Michele Winn)

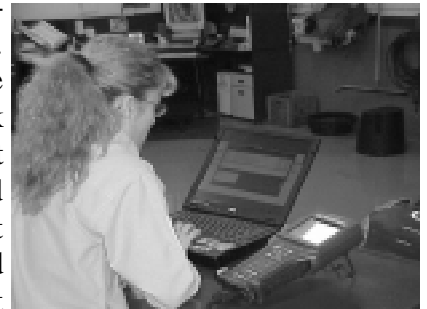
It had just snowed about 6" and was very cold outside, so my test-drive consisted of a drive around the parking lot and into the bay. The service engine soon light was not on, but I did notice the idle was a little rough. I decided to use EASE to pull codes and check history, so rolled the laptop over to the vehicle and hooked up. It had a history code PO300 (random multiple misfire). I checked freeze frame/failure records for "mileage since first failure" (MSFF) and "mileage since last failure" (MSLF). It had been 236 miles since the first failure and 123 miles since the last failure. I have now confirmed that this is an intermittent failure.

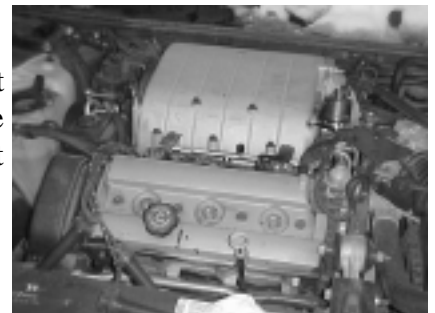
Now I need to know which cylinder(s) are affected. The PO300 is a random misfire, but does not point me to a specific cylinder. Why wasn't this PO300 accompanied by a PO301, PO302, etc. indicating which cylinder(s) had the problem? While Jim and I were discussing the problem, he got a phone call from Jeff Masterman of the Standard Motor Products Training Division. Jim relayed to Jeff the discussion we were having about the PO300 code. Apparently, Jeff had encountered a similar situation recently and found that the vehicle was not capable of displaying anything but a PO300. After consulting Alldata, I found out that Jeff was right! This vehicle can *only* display a PO300. It cannot set a specific cylinder misfire code. So, knowing that, how can I narrow my search? I pulled up misfire counters and found that cylinder #4 misfired 348 times and cylinder #6 misfired 196 times. All the other cylinders showed NO misfire. Now I know which cylinders are affected.

Looking at the engine, cylinder 4 and cylinder 6 are on the front bank closest to the driver's side of the car. My day seems to be looking up! At least it doesn't look like I'll have to take plugs out of the back bank!

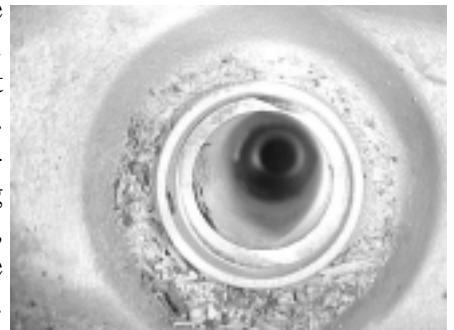
Sure enough, it had platinum “these will last for the life of the car” plugs. The plugs didn’t look too bad, except two of them were covered with oil. The plugs that came out of cylinders 4 and 6 had oil on them from a leaking valve cover seal. As a matter of fact, there was oil standing in the well where the plug sits down inside the head. Cylinder #2 was completely clean. So, what’s the fix? A new valve cover gasket set and a new set of plugs wouldn’t hurt! At only 54,000 miles, this will be a very expensive tune-up!
