# Networking

Newsletter

### On-Car Injector Service Some do----some don't!

## Analysis from the “Sleuth”, Michele Winn

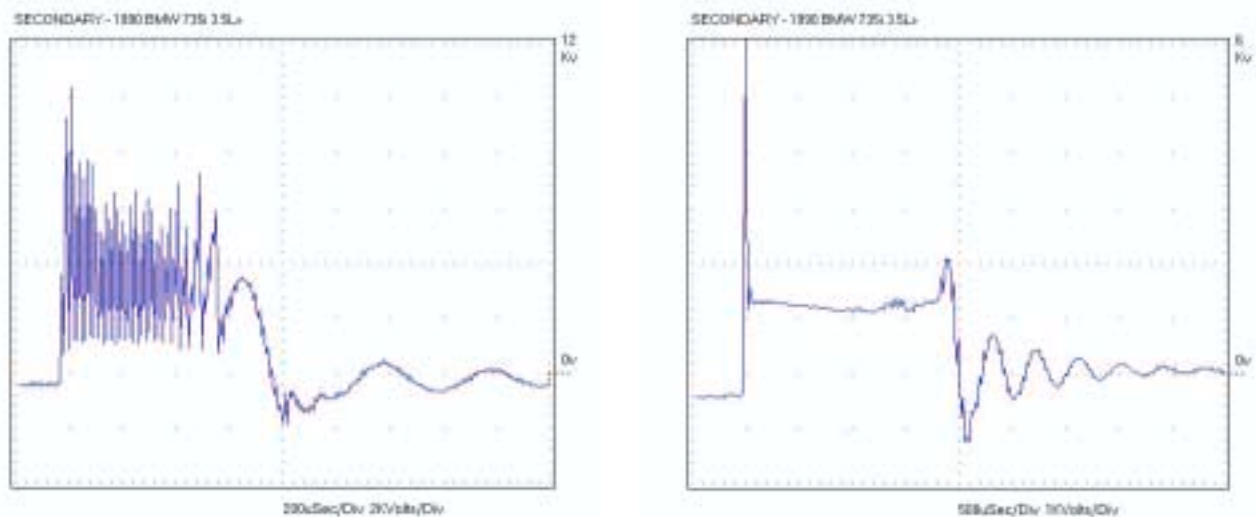
This case study comes from our West coast friend, Brad Peterson. The vehicle is a 1990 BMW 735i with the 3.5L engine and 135,000 miles. The car misses intermittently at idle, but smooths out under load. Testing shows a problem in # 2 cylinder. Idle vacuum was 14 inches before injector cleaning and 17 inches after cleaning.

The picture on the left shows turbulence created by poor fuel injector spray under idle conditions. The right picture shows the same cylinder after a total fuel injection service has been performed on the vehicle.

**Note:** This example has been discussed on the I-ATN technical Discussion channel. Many opinions have been voiced. Some say they believe this to be a defective plug wire or spark plug and others say a valve is being held open with carbon causing this unwanted turbulence. The only thing we know for sure from Brad Peterson's example is that :

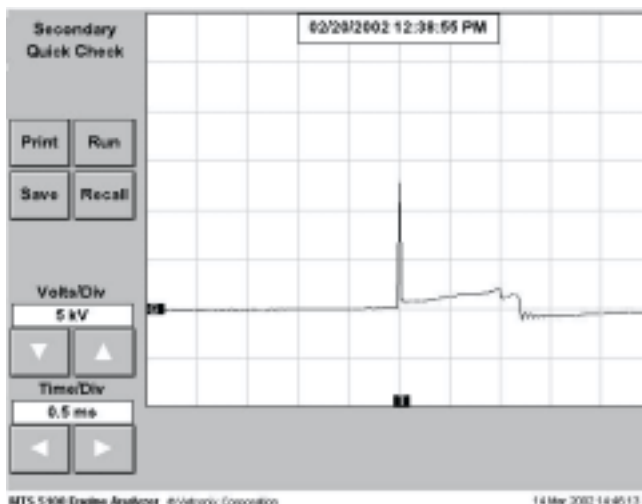
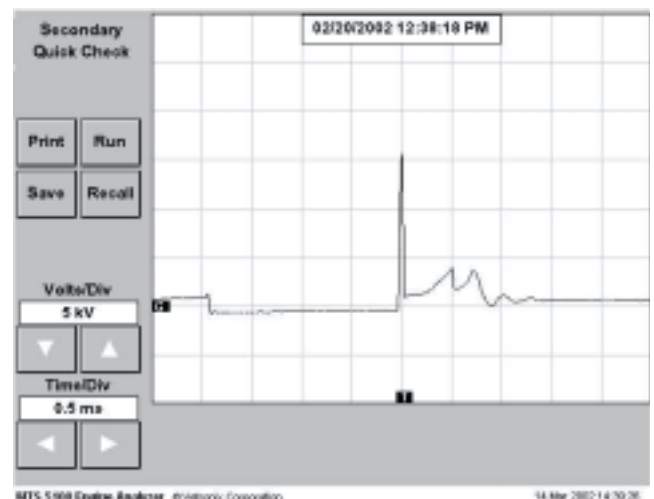
When I got back to the shop, I used the NGS scanner to retrieve codes. It pulled up a P0304 (cylinder #4 misfire). Remember, the previous shop already put plugs and wires on the vehicle, but I was still curious about the condition of the #4 plug. I was very happy to find that cylinder #4 was located on the front bank, passenger's side, so I removed it for inspection. Sure enough, the plug was new. No signs of fuel-fouling, no cracks, nothing unusual. It looked like it had been firing like it should. I didn't see any difference between the #4 plug and the #3 plug, but I also wasn't sure how many miles were on them.

Next, I hooked the Vetronix 5100 scope to the ignition to check and see if I could see anything on the pattern. Remember, this only occurs under light load (in drive around 1800-2200rpm). The picture on the left is cylinder #4 at idle with no misfire. The picture on the right is cylinder #4 under light load, with misfire occurring.

Sure, I can see in the scope patterns that there is a problem, but what's causing it? I checked a few more basic things like fuel pressure and vacuum leaks and I reluctantly decided to consult the flow chart. Here is a summary of the steps:
