Networking

Newsletter

Tech Training

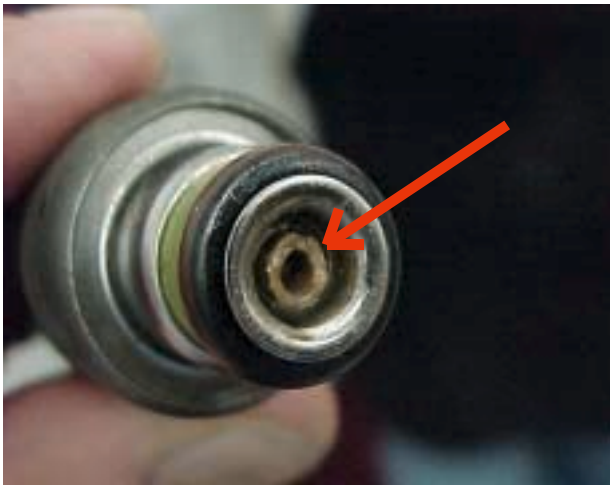
(Picture 1)

While going through injector cores, I came across a very interesting G.M. Multec injector. It was one of their “stamped spray tip” design used in the 3100 “M” engines. It appeared to have a stalagmite growing out the fuel discharge end. At first, I thought it was debris that got there after the injector was out of the engine, but further investigation revealed that it was permanently attached (*see picture 1*).

I contacted Richard Augustus of BG Products, and asked if he could test the deposit to find its composition. I sent the deposit off to Richard and within a few days I got the results: the deposit tested positive for being sugar. This injector now lives in “The Wizard’s Injector Archives“. So the next time you are in the injector lab ask me to show you the sugar injector. If you ever come across an injector that you think would make a good case study, send it off to me with a note and I might just let it live in the archives!

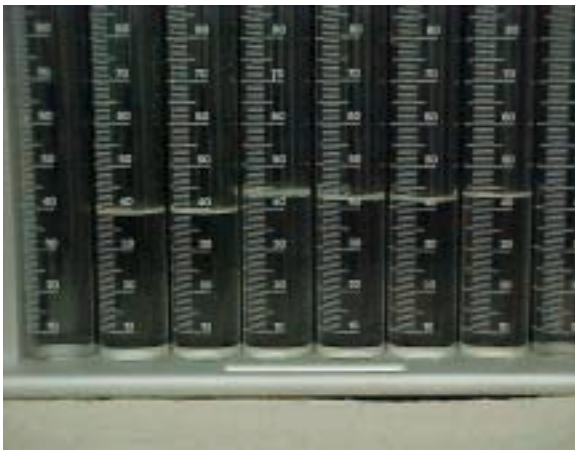
Everyone in the injector lab felt that this deposit looked like crystallized sugar. I thought I would get some pictures and do some testing while this growth was still attached. The deposit affected the flow volume from the injector (*see picture 2*) and it also narrowed the spray pattern (*see picture 3*).

(Picture 2: actual fuel volume as tested on our flow bench)

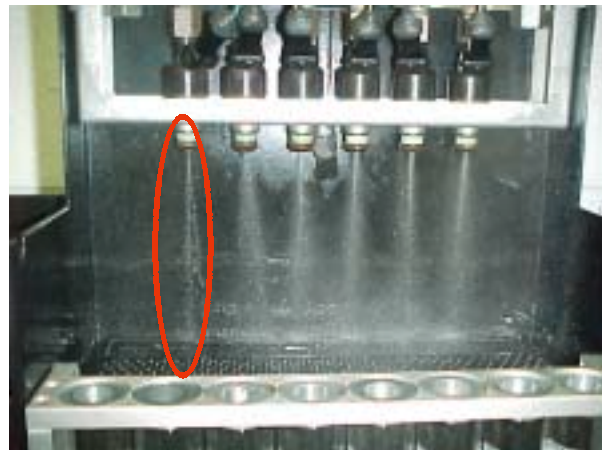
(Picture 3: spray patterns)
