Newsletter

Analysis from the “Sleuth”, Michele Winn

Fuel Injection Service Update from the “Wizard”

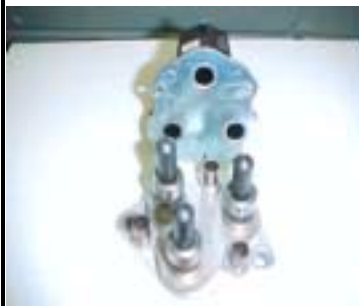
Before I begin a new cast study, I would like to briefly go back to the vehicle we talked about last month. It was a 1993 Chevy Lumina w/ a 3.1L engine with MIL on and stored code 32. To refresh your memory, the flow chart quickly guided me to a faulty EGR valve which had 2 of the 3 solenoids were stuck open. I slammed a new one on, cleared the codes and took the vehicle for a brief test drive (this will come back to haunt me). The customer drove it over the weekend, the MIL came back on and the vehicle was running very poorly. A quick scan showed another Code 32 What now?! The only way I could figure the Code 32 would cause the vehicle to run badly is if one or more of the solenoids were stuck open again. I pulled the valve back off and found all 3 were seated. The EGR system on this vehicle isn't that complicated, so I must have overlooked something. I went back and checked the EGR passages for a second time and found no problems. I decided to put the valve back on, grab the Tech-2 and use the bi-directional functions to activate each solenoid and watch for an rpm change. I checked all 3 at 2000 rpm. #1 & #3 showed an rpm change, but nothing happened when I switched on #2. I looked at all 3 when I had the valve off earlier and they all appeared to be seated. So, was #2 stuck closed? With the valve in my hand, I manually opened each solenoid. #1 and #3 opened with very little force. With lots of pressure behind #2, I could just barely get it to raise off its seat. I had never seen a problem quite like this before, but I went ahead and got a new valve. This time, there was noticeable change when I exercised all 3 solenoids with the Tech-2. Yippee! I'm finally done with this car, but I forgot, it runs bad too. The customer thought it ran worse when it was hot, so I pulled it outside and let it warm up for a while. When I went outside to take it for a drive, I could hear the distinct sound of spark jumping under the hood. Could I really get that lucky? I popped the hood and sprayed down the wires. The car almost died and I could see spark jumping in several places. No need for a test drive until the spark plug wires were replaced. When the customer returned to pick up the car, they mentioned that they had just replaced those wires over the weekend with Brand X (name left out to protect the innocent) and the car had been running badly ever since. OK. Let's go back to the EGR valve. I was trying to figure out what caused the #2 solenoid to only barely open while the others functions properly. Was there a piece of carbon stuck behind it not allowing it to open fully? Let's look. The picture on the left shows the top removed from the valve. Noth-

ing binding or sticking. In fact, with the top removed, it seems to be working perfectly. After reassembly, I still had the same problem. As I was looking at the valve, I wondered what the 3 torx head bolts were for (see picture to the right). Even more, I wondered why two of them seemed to be level with the top of the valve and one seemed recessed. Oddly enough the recessed torx was the one connected to solenoid #2. Just for grins, I thought I would see if I

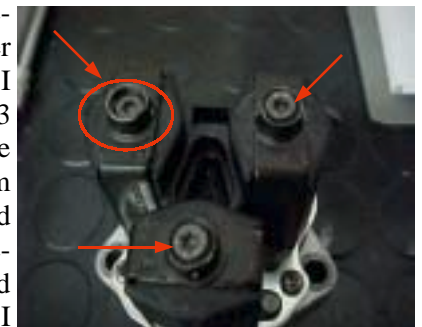
could turn it. Not only did it turn, but unlike the others, it was loose. I turned it until it was about even with the others and AHA! Now the #2 solenoid opens just as far as the others! Turns out this was improperly adjusted from the factory.

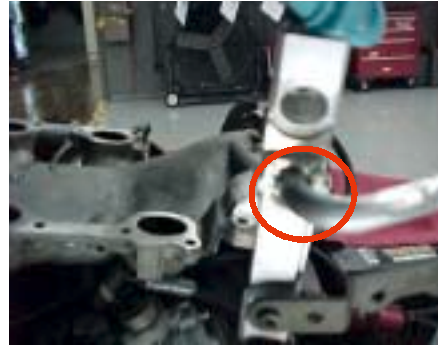
Just about a week after that conversation, Michele scheduled a car into the shop for a fuel leak. The vehicle was a 1995 Chevrolet Beretta 3100 “M” engine. The customer had purchased a set of our “Reconditioned” injectors and installed them himself. He stated the front and back injectors on the right side were leaking. Within a few minutes of getting the car in, Michele confirmed the fuel leak. It did appear it was the injectors on the right side of the engine. She pulled the rail and found that the leak was coming from the crossover tube. (The pictures at the right show the bottom side of the fuel rail where the crossover tube fits into the rear part of the fuel rail) It also appeared that the crossover tube was not fully seated in the rail. Searching our “rail farm” we discovered that the customer had left off the retainer that holds the crossover tube into the fuel rail. We robbed a retainer, installed it on the rail and reinstalled the rail in the vehicle. Michele pressurized the system and the leak had ceased.

Bottom side of the rear portion of the fuel rail where the crossover tube fits.

These two situations made me think that I had better get some o-rings in stock! So, LTS now has the O-ring for the 3100”M” crossover tube. The next time you order a set of injectors for the 3100 “M” engine, you might want to get an O-ring or two, just in case.

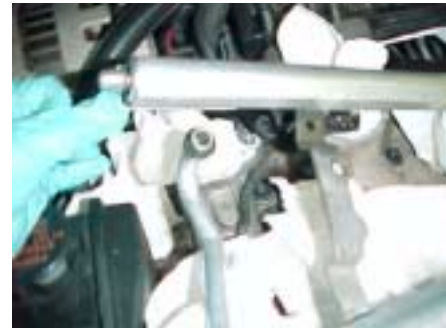
View with crossover tube removed and o-ring exposed
