# Networking

## Tech Training By: Jim Linder

### You just never know???

This case study of a very troublesome car comes from Bob Foote at Beck Service Center Indianapolis, Indiana and covers my above thoughts. The vehicle is a 1993 Pontiac w/a 3100 engine that will not start. Another shop had installed a new (rebuilt) engine that was built at a very reputable machine shop. After doing all the usual tests and "parts evaluations" (nice way to say replacement), Bob was called to look at the car.

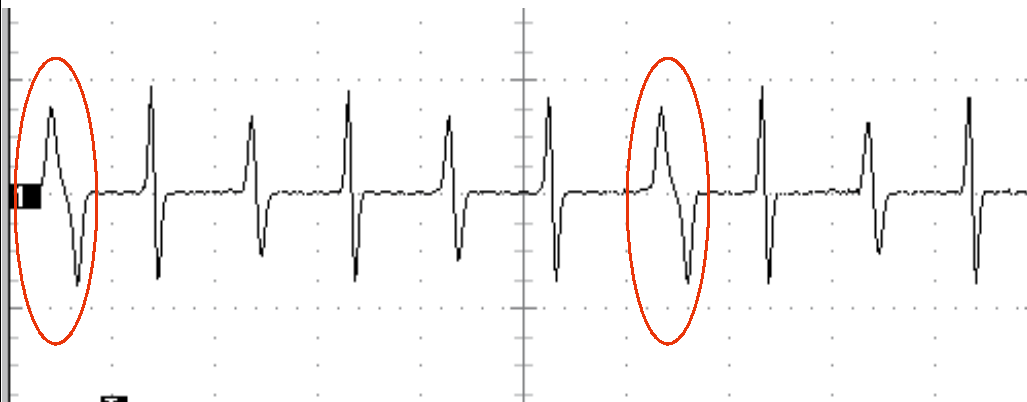
The car had a no-spark condition at all times. Knowing that all electrical parts had been either switched or replaced with known good components, Bob hooked up his 5100 Vetronix scope to check the inputs and outputs from the ignition system and crank sensor. The picture below is what he found at the crank sensor output.

This picture shows the output of the magnetic crankshaft sensor. There appears to be an even signal and one signal every sixth cycle shows a slightly different signature. Knowing the car's history, Bob called us and discussed the above waveform knowing that this was not really a good waveform.

Now, back to Bob's problem. Bob knew that something was wrong with the waveform, but what could it be? All the parts had been replaced but the crankshaft, and the reality of the crankshaft being broken wasn't ever considered to be a possibility.

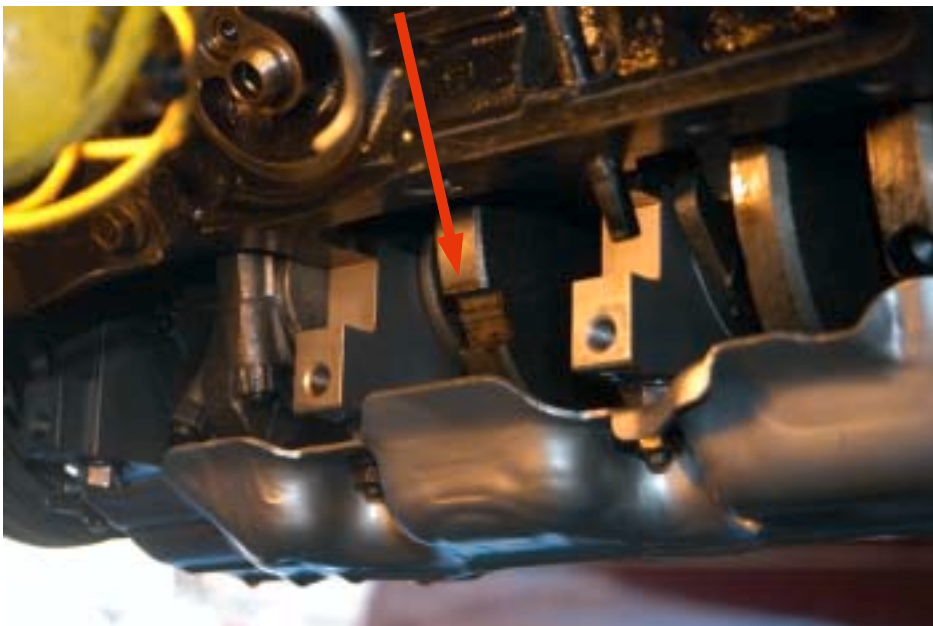
After my discussion with Bob, I remembered (getting harder these days...rbg) that the vehicle that was at Hobbs Automotive years ago with this similar problem had a new oil pan installed before it was towed to the repair shop as a no start. It seems as if the customer had hit a curb at speed and caved in the oil pan. The wreck had closed up the double notch on the crank wheel! After hearing this story, Bob left and had the oil pan removed from the engine to find that the double notch wasn't closed up it was totally broken off the engine! Check out the picture below:

WOW! It seems that the crankshaft had become damaged somehow during the rebuild and no one had noticed the damage.

The engine was removed and another crankshaft was installed and engine started right up. The waveform signature of the good signal is shown on page 4.

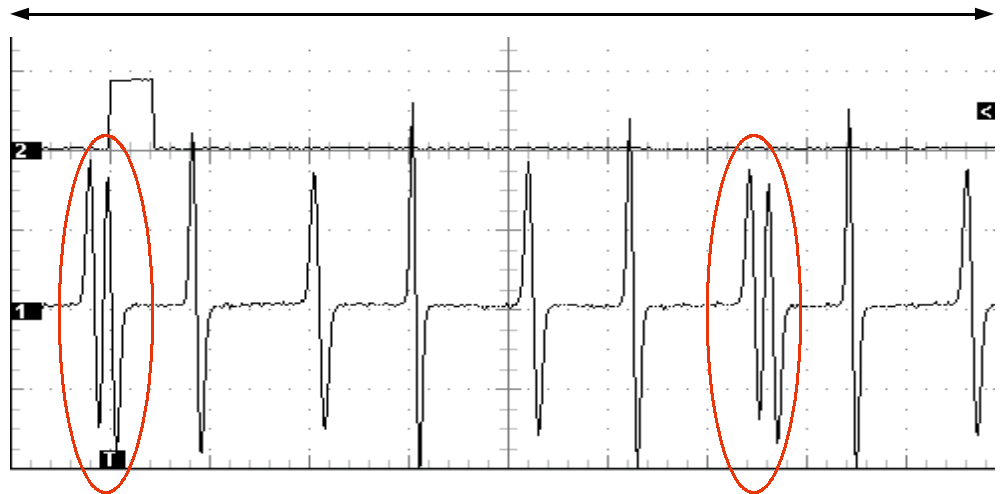
Note that the double notch is shown for proper triggering of injection and ignition and proper spark timing may now occur. I realize this is a rare, obscure problem, but it is the third time I've heard of this happening which means it can and does happen. I complement Bob on knowing the signal was wrong and for taking the time to look for the answer! This would have been very difficult (if not impossible) to diagnose without a lab scope!!
