Newsletter

Analysis from the Guest “Sleuth”, John Thornton

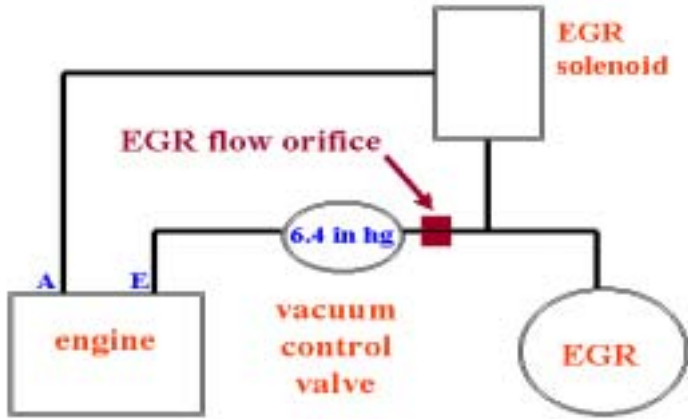
Let’s take another look at John’s simplified drawing of this EGR system. Notice what has been added to the picture this time. (See picture on top of page 3) There was a black, plastic vacuum splice in the vacuum control valve hose going to the EGR valve. John thought there might be a restriction in this splice. As he pulled it off, a slight bulge was evident in this vacuum hose. When he squeezed this bulge, it felt like there was a BB inside.

(Notice we've added an EGR flow orifice. This was not pictured on the original Mitsubishi system diagram)

After slicing open this short vacuum hose, a brass orifice was found to be buried in this hose. This orifice looked like a very small version of a carb main jet. This orifice was almost completely plugged. A cutting torch cleaning tool was used to open the restriction.

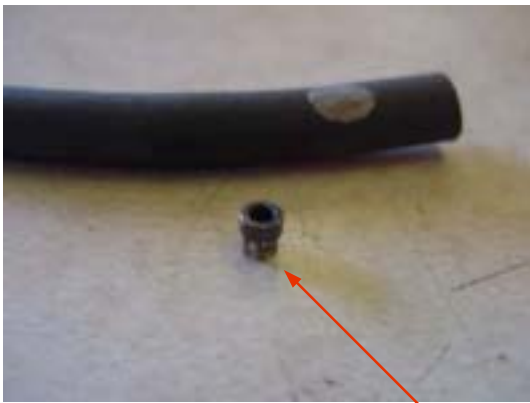
This is a picture of an EGR flow orifice. As you can see, it resembles a carburetor jet.

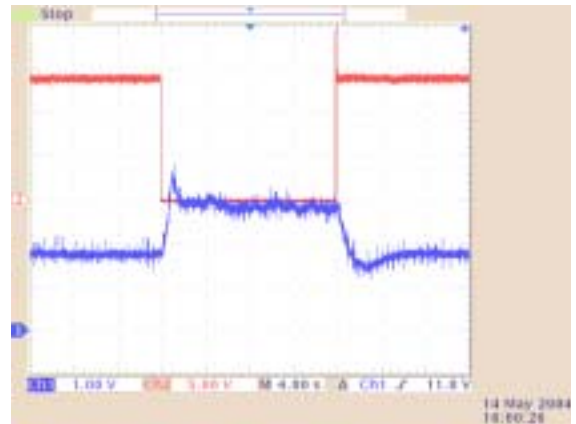
Now let's look at how the manifold pressure sensor responds after cleaning out the hose. Once again, the picture shows the EGR solenoid on top in red and the pressure sensor on the bottom in blue. Now the response is much faster than the 6 seconds measured previously. The response rate appears to be around 1 second.

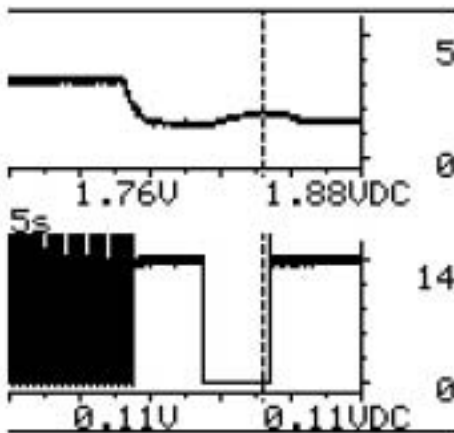
The test drive was repeated after cleaning the EGR flow orifice. A noticeable voltage change can be seen. While the spec is still unknown, it would seem that the P0400 was fixed. The EGR monitor only ran a couple of times. It would not run again unless the ignition key was cycled off. Prior to the repair, the PCM was trying to run the EGR monitor frequently.
