Linder Technical Services

Networking Newsletter

August 2006

A CASE OF MISTAKEN IDENTITY

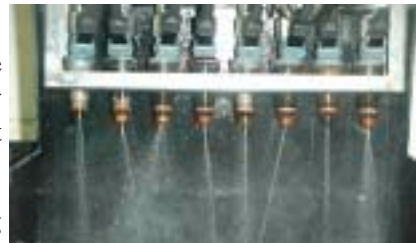
Once I got the injectors hooked up and working, Titus' bargain didn't seem so good. The spray pattern of the injectors was all over the place. These definitely needed the Wizard's magic touch. I proceeded to flow the injectors to show Titus how the spray may affect volume.

The flow was just as bad as the spray pattern. None of the injectors flowed 60-mil like they should. At best, there were 3 injectors flowing 50-mil. Titus agreed to have the injectors cleaned. During the ultrasonic cleaning all sorts of contamination came out of the injectors. Most of it looked to be rust.

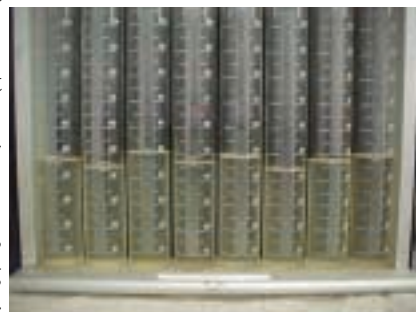
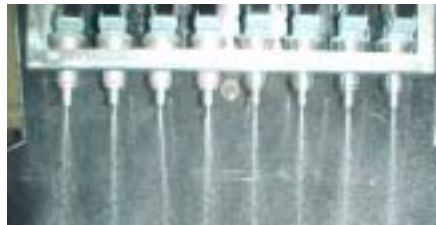
When the injectors were done with cleaning, I put them back on the flow bench. (Middle picture) They all had a good spray pattern. However, why would they all flow only 50-mil? (picture on the right)

Further investigation revealed the injectors that Titus had bought were not 24Lb injectors. The Bosch casting number didn't match any Ford application. They were actually BMW injectors and they were flowing at spec. So what is the moral to this story? The next time you need injectors, listen to the advise of The Wizard. Don't be a Titus!

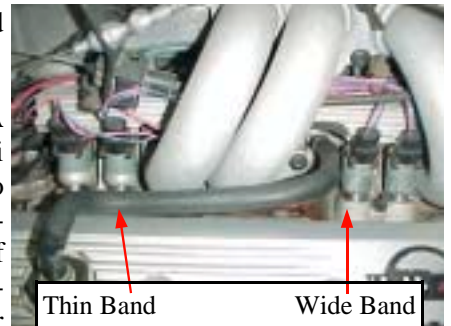
17.3 10.9 17.5 12.2 17.9 17.5 13.5 14.2

All 4 of the thin band injectors were bad and all 4 of the wide band injectors were good. The injector “Wizard” must really know what he's talking about! I was excited to think that I would be able to throw in a set of injectors and ship this thing out the door. I called the customer for approval and padded the labor figure a little anticipating problems. Wow, I'm really glad I did!

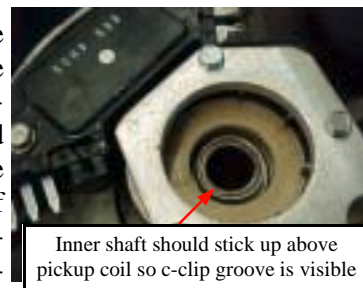
This time the distributor was removed from the engine only to find that the pickup coil was plugged in upside down. Yes, there is an alignment tab on the connector, but if you try really, really hard, you can plug it in upside down. Obviously having the pickup coil leads reversed along with the wrong coil could have been the cause of my backfire and misfire under load. Not only were the leads reversed, but the shaft was actually rubbing on the notches on the inside of the pickup coil and the upper bushing had been pushed down so far that the retaining groove wasn't visible and the c-clip was missing! At this point, we decided to order a new (reman) distributor and start with all good parts.
