Networking

Newsletter

Analysis from the guest sleuth, John Thornton

The vehicle is a 1997 Mitsubishi Eclipse Spyder equipped with a 2.4L 16- valve SOHC engine and about 90,000 miles on the odometer. Customer complaint is MIL on with a code PO400 (EGR flow malfunction). The EGR solenoid has already been replaced in order to try and cure the problem. Using the Snap-On MT2500 scan tool, let's look at the freeze frame information:

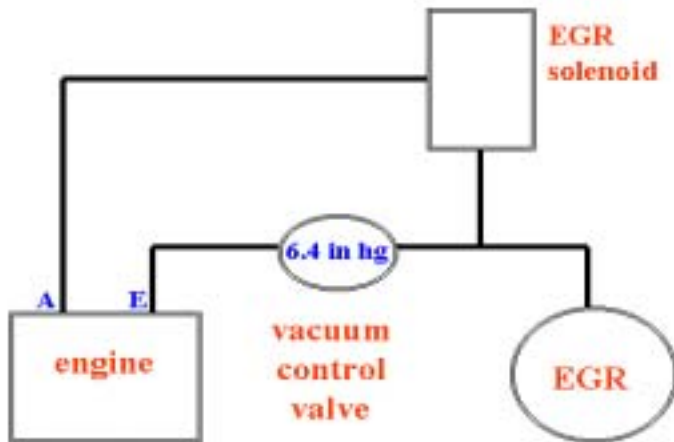
Next, John consulted a diagram of this particular EGR system. While the Mitsubishi diagram looked sort of complicated, it showed that this system was like many others and consisted of a solenoid, an EGR valve and a vacuum control valve. In order to make it more simple for us, John has re-drawn this system. See the picture below:

Here's how this system operates.

- ∅ Manifold vacuum is applied to the vacuum control valve from Port E.
- ∅ The vacuum control valve regulates vacuum to a measured 6.4”hg (The spec in Alldata was 6.7”hg).
- ∅ The EGR solenoid, when de-energized, bleeds manifold vacuum off to a vent at the throttle body Port A.
- ∅ When energized by the PCM, the EGR solenoid blocks the bleed and vacuum is applied to the EGR.

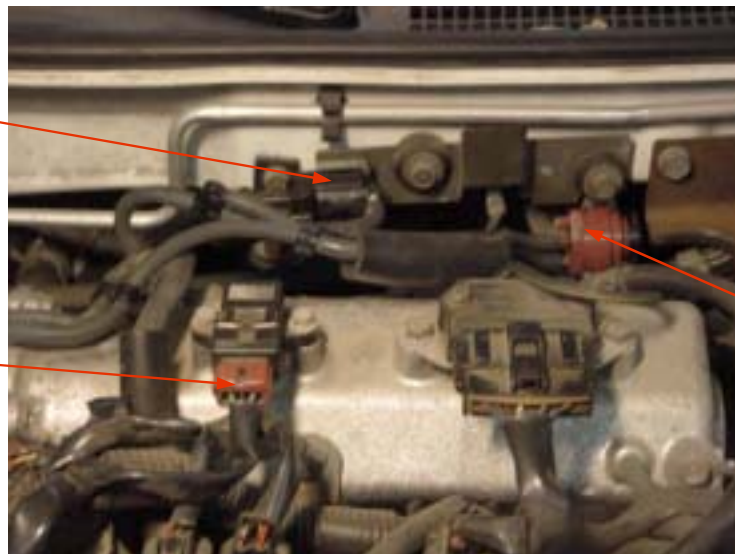
EGR Solenoid

Manifold Differential Pressure Sensor

Before we go any further, let's take a look under the hood and locate and identify the parts to this system.

Vacuum Control Valve

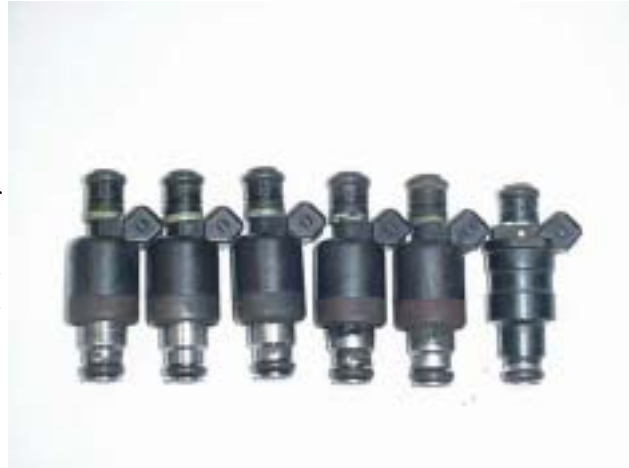
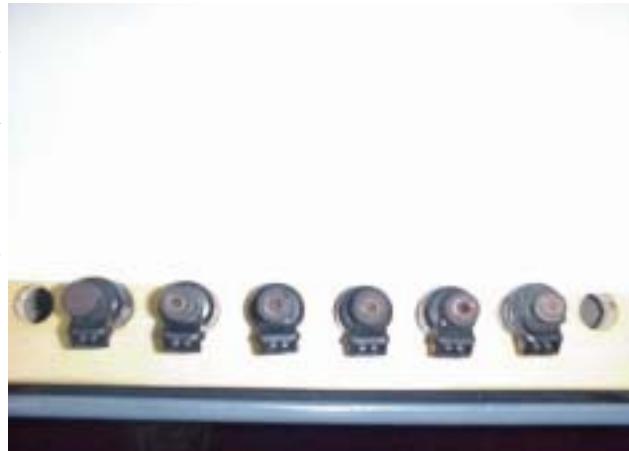
Here's a case where the tech must have been more concerned about who was going to win the Olympics than what was happening in his service bay. We sold a customer a set of injectors and when they sent the cores back, I just about had a heart attack. All of the injectors were plugged up at the filter. I also noticed that one of the injectors had previously been replaced. I had to call to find out if they knew what had happened to cause this. The tech said he hadn't noticed the filters when he replaced the injectors. So, I had to ask:
HAS THE SYSTEM BEEN CLEANED?

Often the question is asked about fuel system contamination. No, not where one or two injectors seem to be lean and fail a pressure drop test, but the incident where all or most of injectors are plugged. I have seen this caused by a few different factors. Some foreign material the entered the system at the tank or as one manufacturer representative told me “Our tanks were not compatible with some blends of fuel and it caused them to rust”. Whatever the cause, this is the worst-case scenario.

What can you do? Start at the tank, drain it, and then remove it. I recommend saving a gas sample to show the customer. The tank must be cleaned; some radiator shops will do this. The fuel pump will need to be replaced also. Remove the fuel filter and discard; you will need to install a new one of these too. Using the supply and return connections, hook up a *two line* fuel injection cleaning system. This will allow you to flush the lines and rail. This may be a lengthy process that takes an hour or two. Once the flushing process has gotten the system clean it's time to remove to the injectors. Remove the injectors and have them serviced off the car or just call LTS for a replacement set. Don't forget to check the system pressure to make sure there is no damage to the regulator.

If you are using a single line type fuel injection cleaning tool it's difficult to do a rail flush. So it might be a good idea to just go ahead and send the rail to us along with the injectors. We can clean the rail in our large ultrasonic tank and make the job that much easier for you.

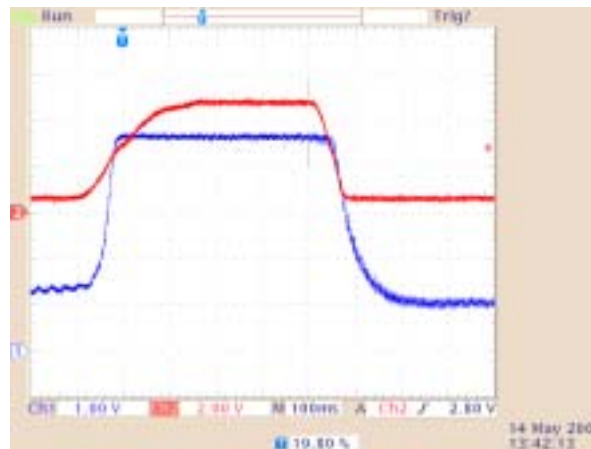
In order to verify that the manifold pressure sensor was working and would respond quickly to throttle movement, John did a quick W.O.T. snap in park. The picture to the right shows it appears to be very responsive. (TPS on top in red, Pressure sensor on the bottom in blue).

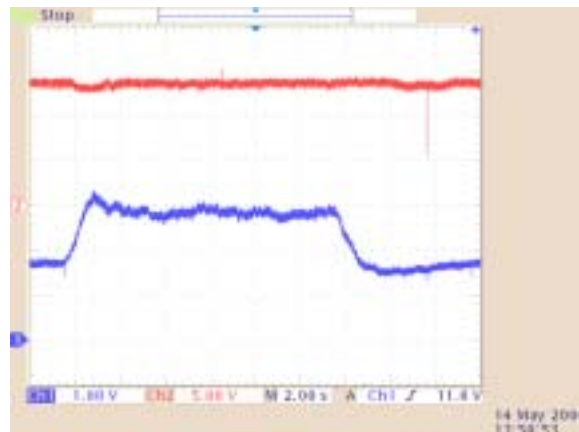
The next picture shows the EGR solenoid on top in red and the pressure sensor again at the bottom in blue. This is what happened when John used a mityvac to open the EGR valve at idle. It made a significant difference in both engine rpm and also in manifold pressure. Maybe not the best test, but it tells us that some EGR flow occurs.
