Networking

Newsletter

Fuel Injection Service Update from the "Wizard"

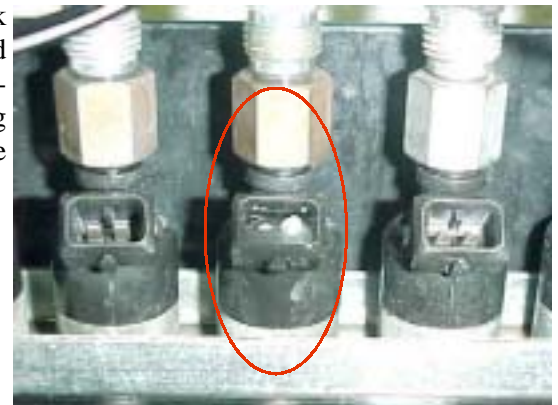
← ANOTHER LEAKING INJECTOR →

I have written articles before about leaking injectors. I would like to mention that there are two possible types of leaks: one from the discharge end (internal) and one from where the electrical connect meet the metal body (external). The leak at the discharge end, in most cases, is caused by dirt or contaminants on the tip and can usually be removed during our reconditioning process. The external leak at the connector is caused by a faulty internal o-ring and cannot be repaired.

Well, here is another example of the 2nd type of leak: external. Fuel is coming up through the electrical connector because of a faulty internal o-ring. It took us a few minutes to get it to look like this. I have seen this before on a few other Multec injectors and on a couple early style Nissan's.

The customer checked the wiring harness and found some green stuff growing back about two inches from the connector. Of course they installed a set of LTS Flow Matched Injectors and a new connector from us and everything was fine.
