Networking

Newsletter

Analysis from the Sleuth (Michele Winn)

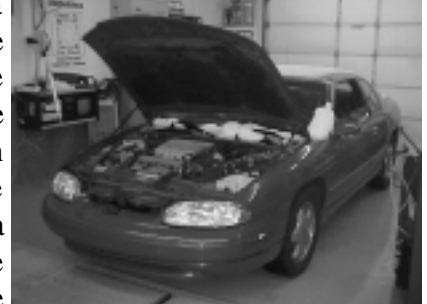
Our case study this month is a 1996 Chevy Monte Carlo with a 3.4L engine and only 54,000 miles. This same vehicle was the focus of our May 2000 newsletter. Back in May, the service engine soon light was on with a code PO1406 for the EGR valve pintle circuit. At that time, we found the pintle was stuck due to carbon build-up. When the customer dropped off the vehicle this time, he didn't hesitate to mention his car had been in our shop less than a year ago with the **"same problem"**. We've all heard that phrase before, and I'm sure that it frustrates you as much as it does me when customers fail to understand that there are *many* reasons that the service engine soon light can come on. Unfortunately for us, the customer only knows that "the light" is back on just like it was the last time you fixed it. After further questioning, he admitted that the light comes on and stays on for several days and then goes out. Also, when the light comes on, the car runs rough, particularly at idle.

It had just snowed about 6" and was very cold outside, so my test-drive consisted of a drive around the parking lot and into the bay. The service engine soon light was not on, but I did notice the idle was a little rough. I decided to use EASE to pull codes and check history, so rolled the laptop over to the vehicle and hooked up. It had a history code PO300 (random multiple misfire). I checked freeze frame/failure records for "mileage since first failure" (MSFF) and "mileage since last failure" (MSLF). It had been 236 miles since the first failure and 123 miles since the last failure. I have now confirmed that this is an intermittent failure.
