Networking

Newsletter

Tech Training

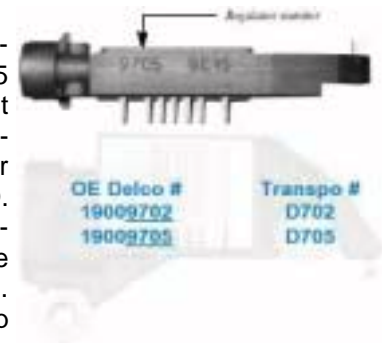
The 3.1-liter V-6 engine family is used in the following vehicles: 97-98; Buick Century, Chevrolet Lumina, Chevrolet Monte Carlo, Pontiac Grand Prix. These vehicles can have either of the (2) alternator/regulator combinations listed. The key in this situation is to look in the trunk for the accessory package tag that will have the following I.D. K68 package will use the 10464071 with the D705 and will have the "smart cluster panel". The K60 package will use the 10463964 with the D702 regulator and use a standard instrument panel."

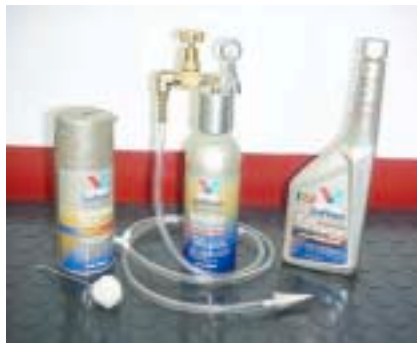
All EGR flow would be diverted to the cylinder with the open passage and would cause a misfire. I spent more time over-thinking this problem than it actually took for me to remove the upper intake, clean the passages and put it back together. Thanks to Randy Dillman of LTS North for helping me get this one straightened out.

The last step in the process (according to the TSB) is to run 2 cans of Carburetor Tune Up Cleaner (or equivalent) through the engine. If the customer had done some preventative maintenance, clogged EGR ports may never have become an issue.

I chose to use the Valvoline 3-step system (part# 071). One bottle is poured in the gas tank, one is drawn into the intake through a vacuum hose and the other is used for cleaning the throttle body. Recently we did some testing on Valvoline's new fuel injection cleaning chemical and we were pleased with the results, so that's why I decided to use their product.
