# Networking

## Tech Training By: Jim Linder

### You just never know???

This case study of a very troublesome car comes from Bob Foote at Beck Service Center Indianapolis, Indiana and covers my above thoughts. The vehicle is a 1993 Pontiac w/a 3100 engine that will not start. Another shop had installed a new (rebuilt) engine that was built at a very reputable machine shop. After doing all the usual tests and "parts evaluations" (nice way to say replacement), Bob was called to look at the car.

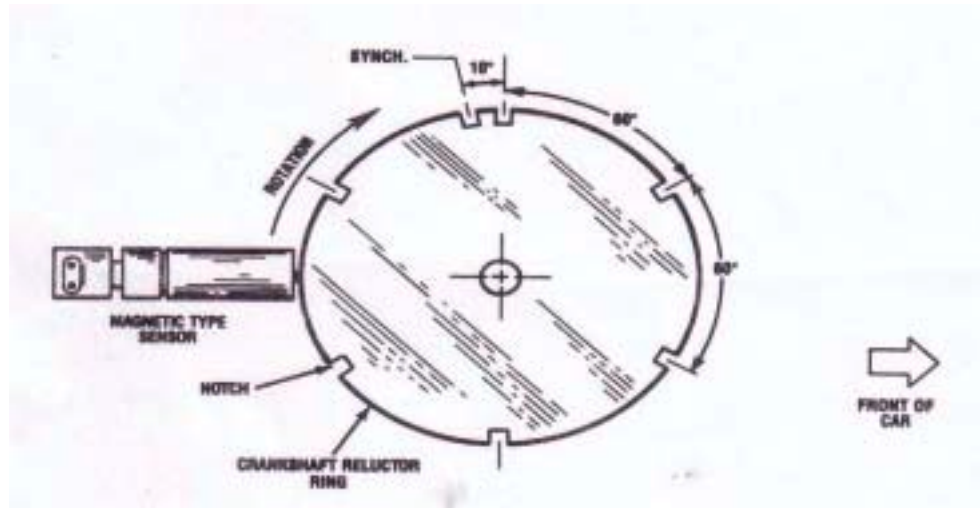
The strategy for the 3100 engine is that the once the ECM sees the number one sync (double notch), it skips the first 60 degree notch and fires the 3-6 coil pack, skips the third 60 degree notch, sees the next one and fires the 2-5 coil pack, then skips the next 60 degree notch and fires the 1-4 coil pack. After the double notch signal is seen, the ECM must see a total revolution of the crank and starts firing of the ignition system 60 degrees ahead (needed for spark advance). This double notch is needed not only for ignition but also for E.S.T. (electronic spark timing), fuel injection and engine rpm signal by the ECM.

Now, back to Bob's problem. Bob knew that something was wrong with the waveform, but what could it be? All the parts had been replaced but the crankshaft, and the reality of the crankshaft being broken wasn't ever considered to be a possibility.
