Linder Technical Services

Networking Newsletter

August 2006

A CASE OF MISTAKEN IDENTITY

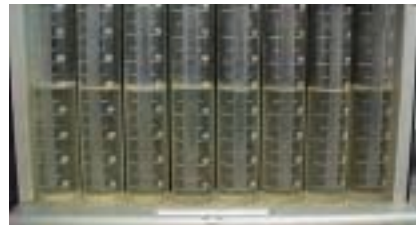
When the injectors were done with cleaning, I put them back on the flow bench. (Middle picture) They all had a good spray pattern. However, why would they all flow only 50-mil? (picture on the right)

Further investigation revealed the injectors that Titus had bought were not 24Lb injectors. The Bosch casting number didn't match any Ford application. They were actually BMW injectors and they were flowing at spec. So what is the moral to this story? The next time you need injectors, listen to the advise of The Wizard. Don't be a Titus!

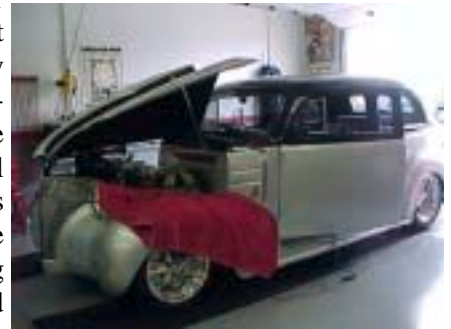
A customer called with a problem on a 1939 Chevy Sedan w/ 1991 Corvette engine. He bought the car in Sept. 2004 and it hasn't run right since he drove it off the lot. The car starts hard, idles rough, runs very rich and intermittently stalls at stops. The customer mentioned that recently when he was out of town, the car started running so badly that he had to have some “work” done on the distributor but he still didn't feel like it was right. He felt like there was a problem with the fuel injectors and possibly with the distributor. Oh, and then he mentioned that he really has no paperwork on the car. He “thinks” it has a painless wiring harness, possibly a stock GM ECM, but with some sort of a chip and he's not sure if anything has been done to the engine internally. Then he reminded me that it's “just a 1991 Corvette engine”, so how hard could it be?

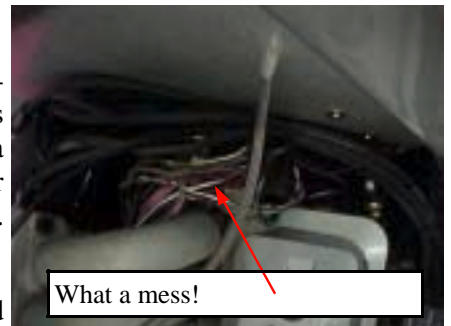
All 4 of the thin band injectors were bad and all 4 of the wide band injectors were good. The injector “Wizard” must really know what he's talking about! I was excited to think that I would be able to throw in a set of injectors and ship this thing out the door. I called the customer for approval and padded the labor figure a little anticipating problems. Wow, I'm really glad I did!

I am very familiar with these engines and I've become fairly quick and comfortable with changing injectors on them. However, the first thing I noticed was the A/C Compressor (aftermarket) would have to be removed. No big deal, just 3 bolts and it was out of the way. Removing the upper plenum went smoothly with no major problems except when I removed the coolant lines, the pipes were very crusty, so that required some cleaning before reassembly. With the top plenum off, I could see a mess of wires running everywhere. As you can see from this picture, even without removing the plenum, it didn't look like much care was taken when the wiring was done. Jim surveyed the mess and said that he would go get some tape and wire loom and tidy everything up before I put it back together. I took a break to rest my back and Jim came back to straighten up the wires. At that time, he found one of the wires on the alternator (which was put together with a butt-connector), was broken. He soldered in a new wire and finished wrapping the wires.

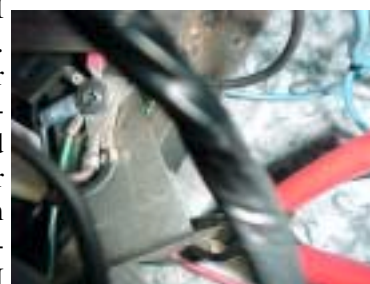
I decided it was time to locate the ECM. Easier said than done. After 1/2 day of searching and tracing wires, Walt finally found it hidden behind the only interior panel that did NOT have velcro or a hinge. Yes, it was a stock GM ECM, but the yellow "crayon" markings on it indicated it came from a junkyard. I remembered the customer mentioned there might be a "chip", so I took off the cover to discover a Jet Products chip. A quick call to the Jet Products hotline with the part# told me that the chip was a "spark and fuel upgrade". Nothing against Jet Products or any of the other manufacturers of performance chips, but I can't tell you how many times a car came in running badly and ALL I DID was remove the chip. So, out it came. At this point, it couldn't hurt. While I was messing around with the ECM, Jim was back looking at another ACDelco book for a wiring diagram of the 4-wire distributor connector. Almost simultaneously, he shouted that one of the wires was a computer ground and I shouted that I had located a ground connection that was only finger tight. There were 7 different wires at this particular connection, most of them labeled.....yep.....one of them was for the ECM. Could this be the problem? Due to the location of the ground, there was no way to get it tight, so I relocated it to a more accessible spot a few inches away. With that tight, and the harness plugged in at the distributor, we cranked the engine.....and it started! Not only did it start, but it ran great! No misfire or backfire under load, no rough idle, just a smooth-running engine.

So, would fixing the ground wire have fixed this car to begin with? I don't think so. Remember I had 4 shorted injectors AND don't forget that the ignition coil was incorrect and the distributor shaft actually making contact with the pickup coil I don't think any SINGLE part would have fixed this car. It was a combination of things that took way too long to track down. But, at least it's fixed, out the door and the customer is happy. I only hope he DOESN'T recommend us to his fellow hot rod buddies!
