# Networking

Newsletter

## TECH TRAINING

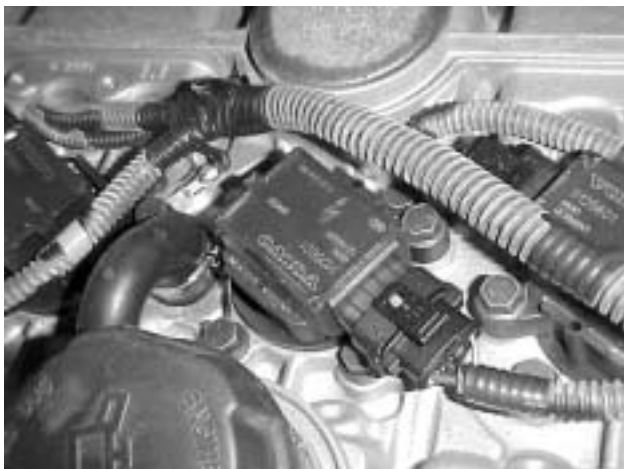
One of the newest systems we discussed was the COP (Coil On Plug) Ion-Sensing system found in on a 1999 Volvo 570. (Yes, some of our students do drive expensive cars) This system uses a single coil per cylinder (5 cylinders) and utilizes the latest Ion-Sensing Interpretation Ignition system. This system uses only a single oxygen sensor (B1S1 behind the cat) for emission verification and uses the Ion gap system for individual *cylinder knock control, cam phase sensing, pre-ignition detection, and misfire/combustion quality/lean limit.*

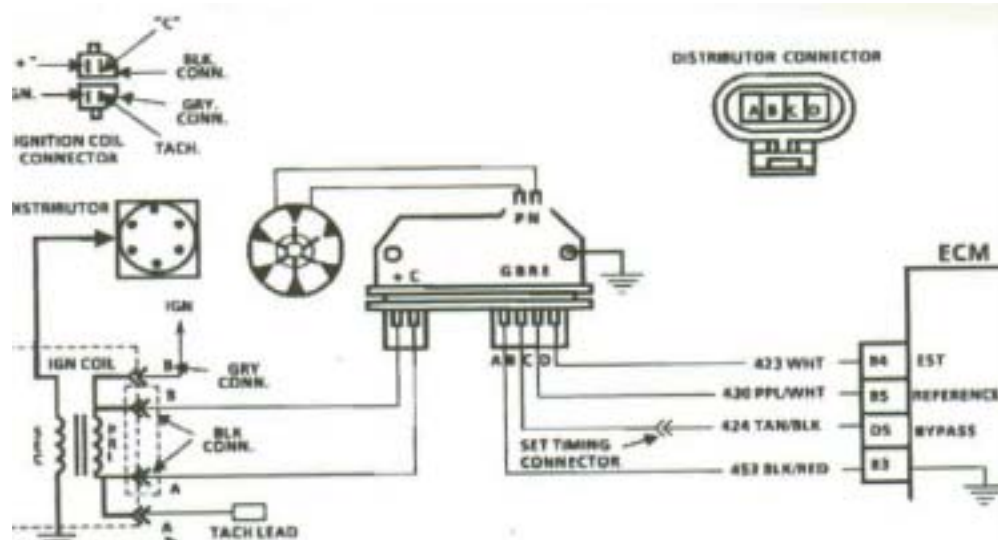
I’m sorry I didn’t take a picture of this car, but I’ll try to describe it to you as best I can. The check engine light came on as I pulled it into the bay. As a matter of habit, I rolled down the (power) window on the driver’s side before I got out. You guessed it, it went down about 3” and the front corner did a nose-dive. I’ll fix that later. Next, I popped the hood, but of course, it didn’t open. After much beating and banging,, I got it unlatched. I knew what would come next, so I grabbed a prop rod before I bothered to raise the hood. It was time to find a wiring diagram, flow chart and do a little homework on how the EST circuit functions. The picture below is a wiring diagram from Alldata.

I’d be lying if I said that I found the problem using only the wiring diagram. I also printed out the Code 42 flow chart and started from the beginning. I’ll be the first to admit that sometimes flow charts can get you into trouble, but if you study the chart and try to understand exactly what each step is testing for, I think you will learn a lot about the system and probably even fix the car (in spite of the flow chart). A copy of the flow chart is found on the next page. Let’s take a look and see if we can fix this car.

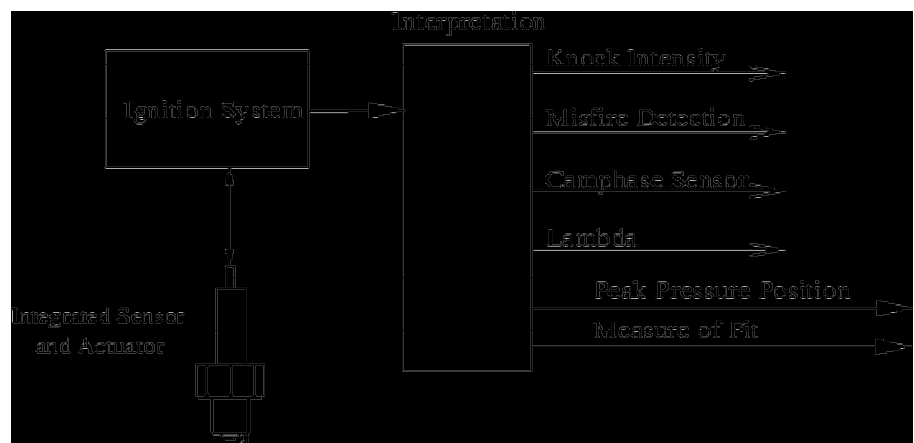
## ION-GAP SENSING SPARK CONTROLS

The spark plug can, using signal interpretation, function as sensor for several parameters. Knock intensity and misfire are already implemented in production cars as a basis for virtual engine-doctors. Lambda-sensing and peak pressure position estimation can be used in virtual engine fine tuners. Variations in engine speed together with crank shaft models can be used to conclude misfire by for example lacking torque pulse or to estimate cylinder pressure from derived torque fluctuations. Usage of the spark plug as an integrated actuator and sensor leading to ionization current interpretation is the path taken here.
