# Networking

Newsletter

## Fuel Injection Service Update from the “Wizard”

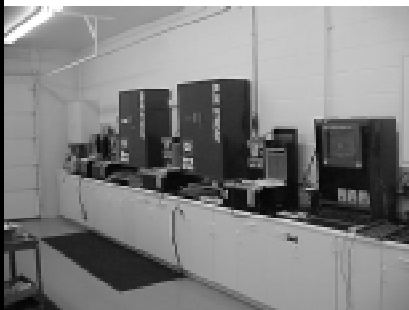
The picture to the left shows the new fuel injection lab. Doug Garriott, the fuel injection "wizard" will move from a room that is not much bigger than a closet to an area that is approximately 30 x 15 feet. We will also add two more ASNU fuel injection machines to the injection lab. Doug will also have a smaller room dedicated to core storage and clean-up.
