Linder Technical Services

Networking Newsletter

February 2007

Doug's "Dirty Dozen" Part 2

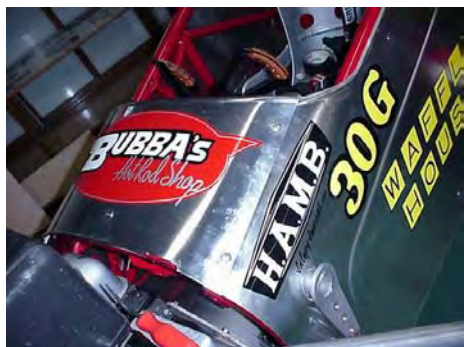
Our car came together pretty quick as I have had this old GMC 302 six-cylinder engine that came out of a pulling tractor. It's 322 cubic inch and has two AFB four barrels, 12-to-1 pistons and a Howard roller camshaft. It really ought to run very well in this class once we get thru the tire smoke. A pile of steel tubing, a Morris front axle and 1958 Edsel 9-inch rear and we are almost ready to run. A little red paint, some Waffle House cheese eggs during our planning meeting and it looks like we have another project to begin the learning curve on. Updates will be on the www.lindertech.com web site as we go.

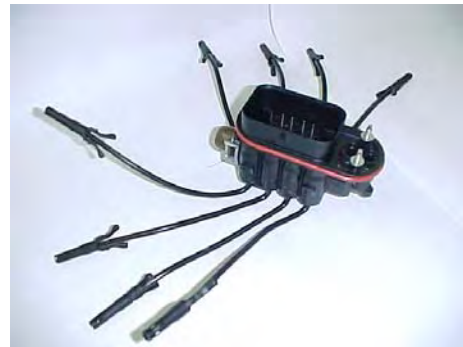
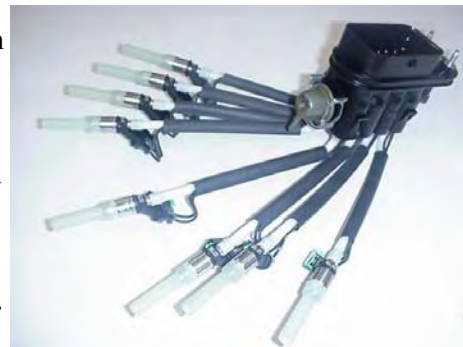
Type: Poppet valve at the end of each tube with an individual injector for each tube in a metering body.

Symptom: The poppet valves are known to stick causing a misfire. The injectors may leak fuel into the wiring harness cavity of the metering body (which can lead to fuel following the wiring harness to the PCM). The pressure regulator may also leak fuel causing a rich mixture.

Recommendation: Replace the original poppet style unit with the NEWER mini injector style. This unit uses a mini injector at the end of each tube. There are plastic injector protectors attached to each injector that fits into the intake ports protecting the injectors from carbon and sticking. The unit is a direct replacement. Always replace the upper plenum gasket when replacing this unit.

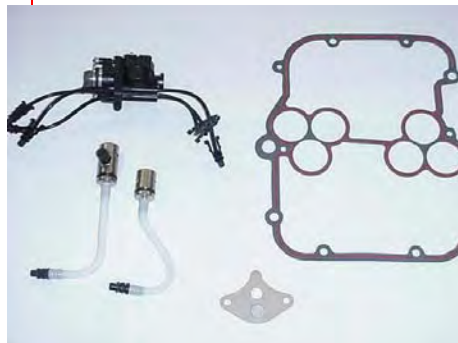
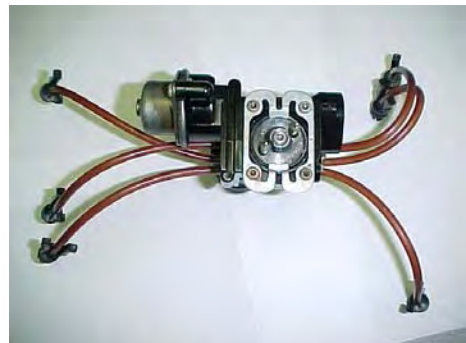
Type: Poppet valve at the end of each tube with only one injector in the metering body to feed them.

Symptom: The poppet valves are known to stick causing a mis-fire. The pressure regulator is prone to leaking as is the fuel supply and return lines that are located under the upper plenum.

Recommendation: Reconditioned LTS units work GREAT especially when they have our upgraded pressure regulator installed in them. When servicing these systems it is best to replace the CPI unit and the supply and return lines.
